ASSESSMENT OF BRIDGE STRUCTURE DURABILITY – ANALYSIS AND EXPERIMENTAL VERIFICATION

The paper is focused on the problem of durability of RC structure exposed to the typical ambient conditions for bridges. The causes and degradation processes of the structures, mechanisms of concrete carbonation and chloride penetration are described. Theoretical model which allows the prognosis of all changes affecting construction safety in time is presented. The findings of the theoretical analysis have been compared with the results of the experimental research of viaduct in its advanced degradation stage as well as the material samples taken from them.

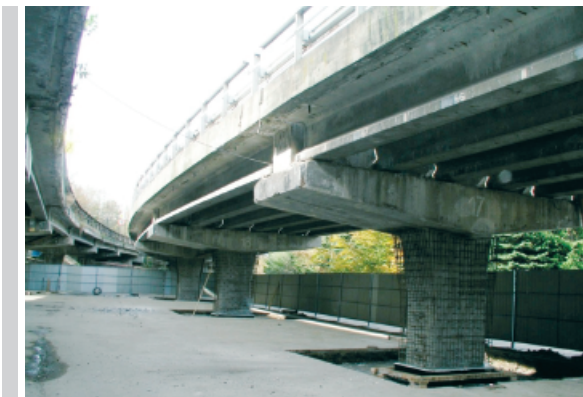
Figure 1.
View of viaduct before repair

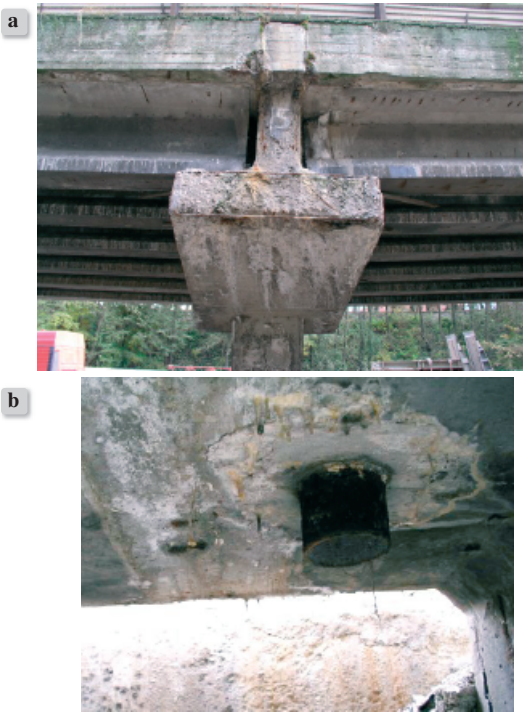
Figure 5.
Bridge before repair: a) view of the investigated crosshead in the axis no. 16, b) non-tight collector above the pier cross-beam of bridge

In order to evaluate the initial safety margin for crosshead no. 15, bending moment resulting from loads is compared to the evaluation of the load-bearing capacity at a critical cross-section located below a leaking expansion joint (Fig. 2 and 5). The geometry of the cross-section is as follows: $d = 0.69$ m, $A_s = 31.3$ cm². The initial safety margin (15%) results from the difference between the initial load-bearing capacity of $M_{Rd} = 773$ kNm and the maximal bending moment in the cross-section at $M_{Ed} = 672$ kNm (Fig. 7). This margin is constant until corrosion propagation period starts. To establish the relationship

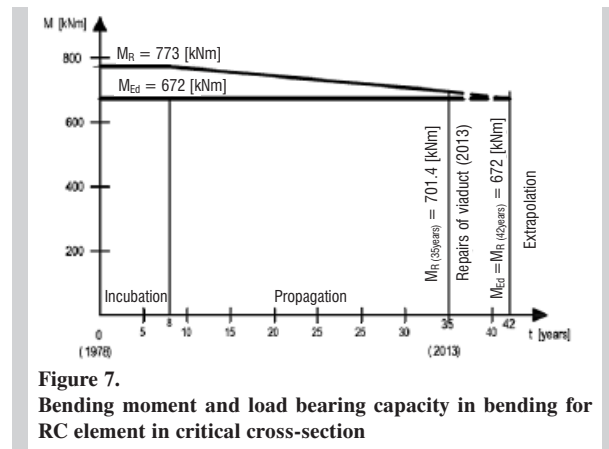
Figure 7. Bending moment and load bearing capacity in bending for RC element in critical cross-section

For the age when renovation was started (2013), the residual load bearing capacity in bending was determined at $M_{Rd(35\text{years})} = 701.4$ kNm. Theoretically, decreasing load bearing capacity in the analysed cross-beam would be exceeded after ca. 42 years since the beginning of viaduct exploitation (i.e. 7 years from the repair undertaken).
